Crews Clean Up Contaminated Starmet Corporation Buildings

□ WED FEBRUARY 22, 2017 - NORTHEAST EDITION #4

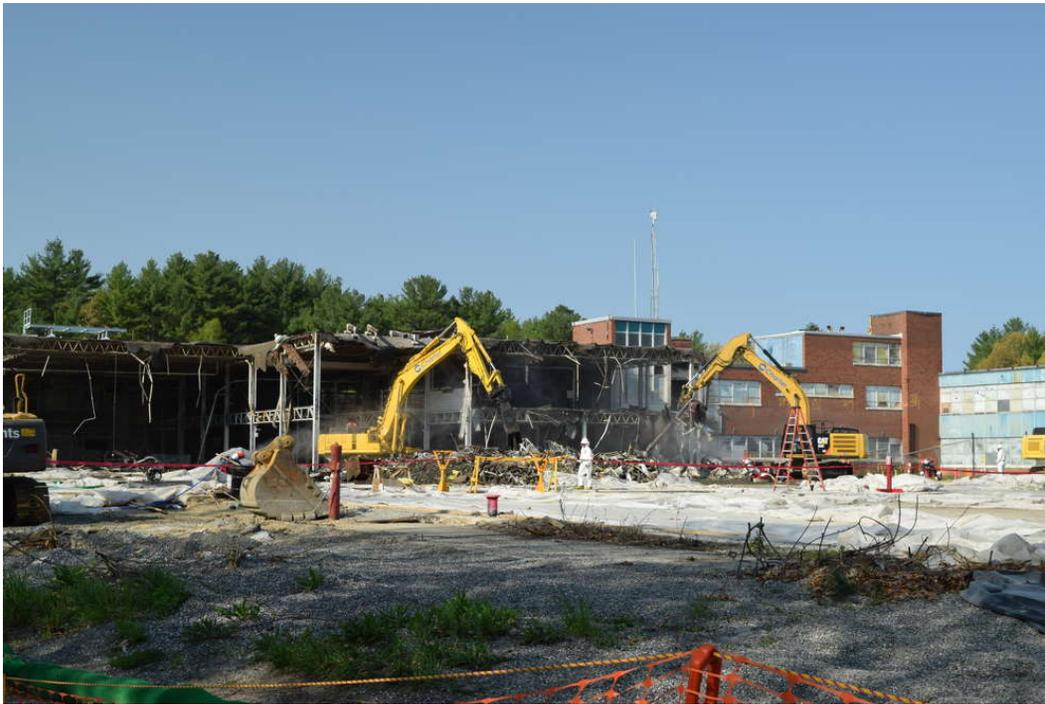
It took subcontractors three years to remove the contaminated radioactive materials from the site, a former nuclear research and depleted uranium weapons facility.
